MEMORANDUM

RE: Intersection @ Park Ave and Route 2's Frontage Roads

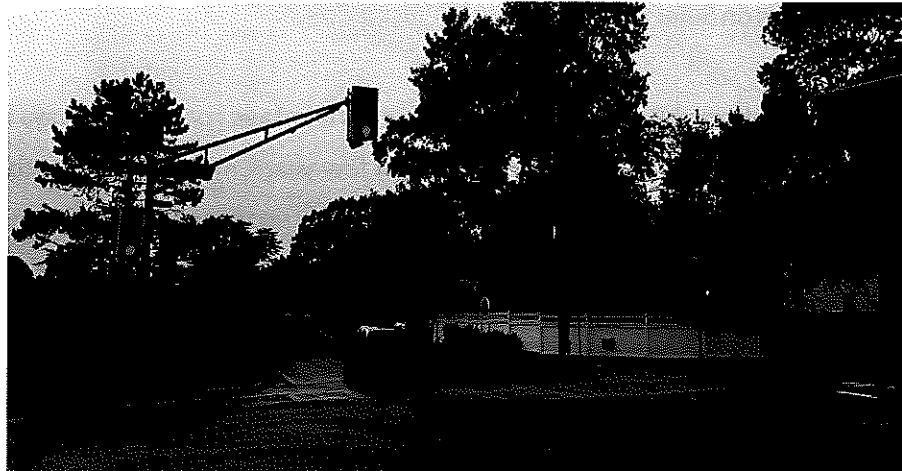
Maintenance at these signals is also infrequent. Concord Turnpike's approach on Arlington's side of the interchange has an extremely dangerous situation that could confuse a driver into thinking

they had a green light, because of a missing visor on a Park Avenue signal, as seen in the photo to the right. Furthermore, outdated "doghouse" style left turn signals currently exist at this location. MassDOT

- Perform maintenance on this signal, to check that it is up to MassDOT standards.
- Install Flashing Yellow Arrow left turn signals to replace older style 5-section signals.
  - Program a pedestrian protect phase, so that if a pedestrian clicks the crosswalk button, left turns are converted to protected only so that pedestrians can cross in a safer manner. (See image on right)
